Your Property Inspection Report

**Property Address:
1234 Any Street
San Diego, CA 92124**

Inspection Date: June 22, 2007

Allegiant Property Inspection, Inc.
858-382-3607
www.APIInspection.com

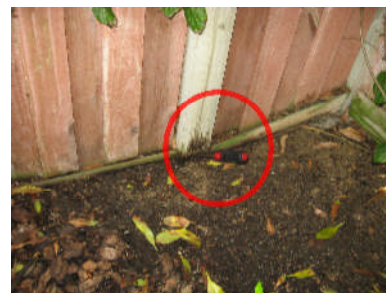
- Condition:** Type: Wood. Earth to wood contact was noted in one or more areas at the exterior. Some wood damage noted. Recommend eliminating earth-to-wood contact and repair as necessary.

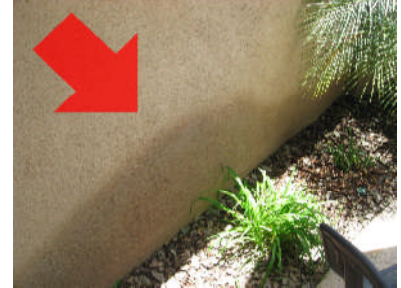
Wall covering materials are: Stucco. Common cracks noted. Some stains were noted on the stucco. Some of these appear to be from sprinkler head spray. Recommend adjusting the sprinkler heads so they do not spray on the structure, fencing, etc. General condition of the exterior walls appear serviceable.

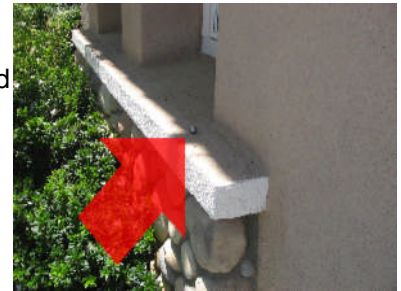
One or more of the exterior window sills have areas that can collect water. Exterior window sills should be sloped to drain to prevent standing water. Recommend repairs as necessary.

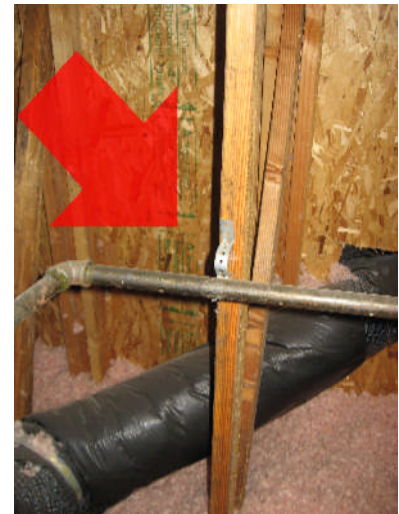
Gas lines in the attic lack proper support in some areas. Recommend further evaluation by a qualified contractor and repair as necessary.

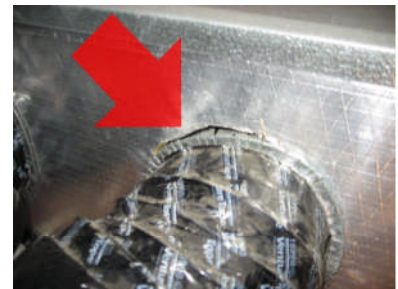
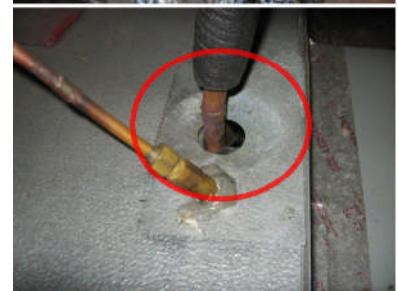
Gaps were noted at the plenum where the ducts are connected and where the A/C refrigerant lines go through. This unit is not secured properly and it is not level. The unit was making unusual noises while in use. Recommend further evaluation by a qualified HVAC contractor and repair as necessary.

Condition: Gaps were noted at the plenum where the ducts are connected and where the A/C refrigerant lines go through. Recommend further evaluation by a qualified contractor and repair as necessary.

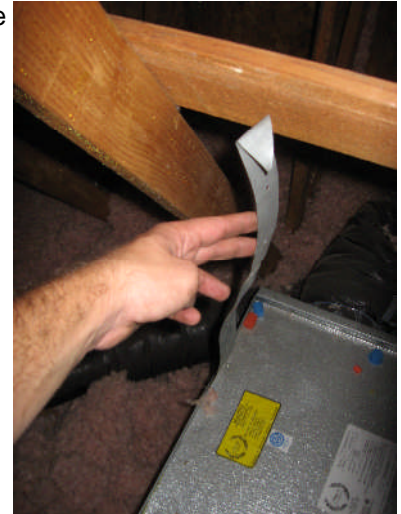
This unit is not secured properly and it is not level. The unit was making unusual noises while in use. Recommend further evaluation and repair as necessary by a licensed HVAC contractor.

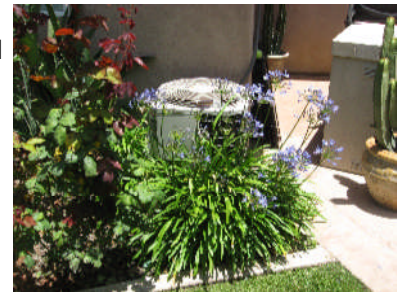
Recommend clearing soil and mulch at base of the condenser units at the exterior to prevent damage and clearing vegetation around the units for proper function.

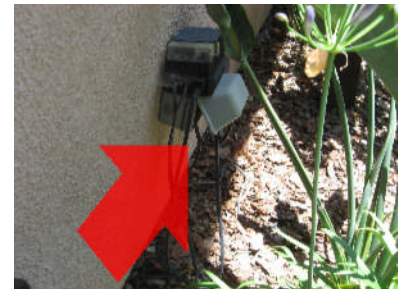
Exterior Walls: One of the "in-use" electrical outlet covers should be closed to keep water out. General condition of the exterior electrical appears serviceable.

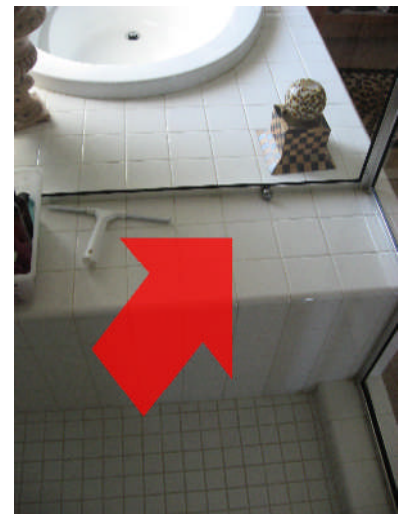
Master Bathroom: One or more areas inside the shower are not sloped towards the drain. This is a fairly common occurrence. However, it can result in water accumulating against the walls or benches and possibly penetrating into them. This could lead to water damage and environmental concerns. Recommend further evaluation and repairs as necessary to prevent any water penetration and/or damage.

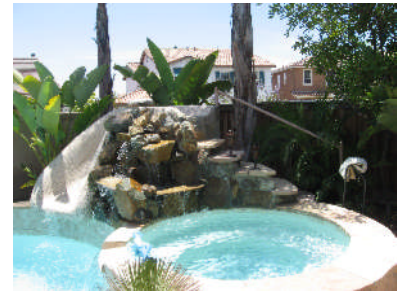
The steps, guardrail and slide at the pool area are considered to be a safety hazard, especially for small children. Recommend having a qualified contractor make modifications such as installing a proper guardrail with gaps no larger than 4" wide and installing protective fencing to keep children from accessing the slide for enhanced safety.

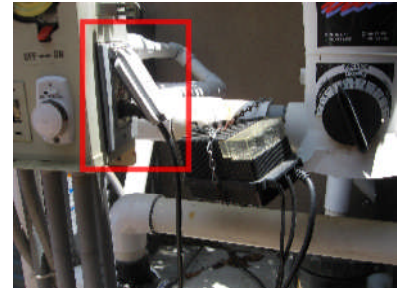
The pool/spa GFCI receptacle is being used for appliances or systems that are constantly in use and aren't equipped with an "in-use" receptacle covers for wet locations. This is a safety hazard and poses a risk of both fire and shock. Recommend installing "in use" covers where necessary.
